Manhole Inspection Summary

Manhole # S27I__005MH

Insp Date: **5/30/08 10:49 AM**

Location Address: **924 W Lombard St**

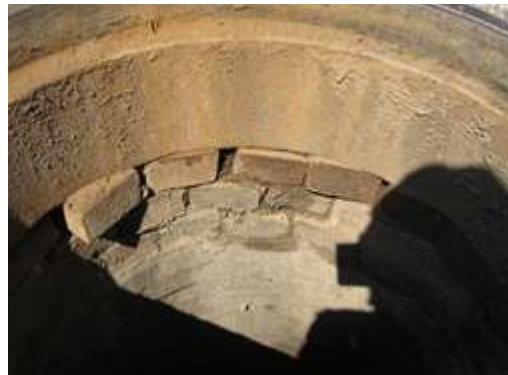
Defect 7

infiltration lid frame, chimney missing
mortar infiltration

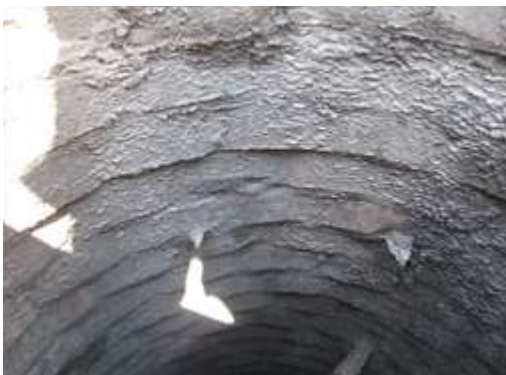
Defect 6

missing rung, infiltration seen coming
from chimney

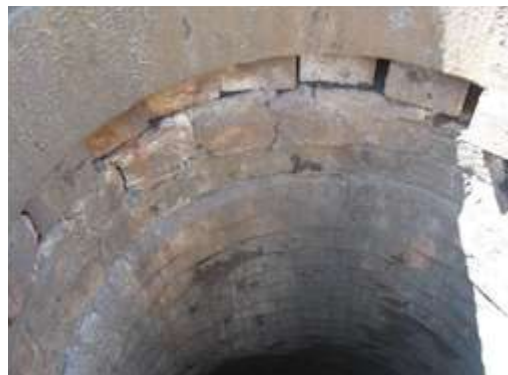
Defect 5

missing mortar infiltration chimney

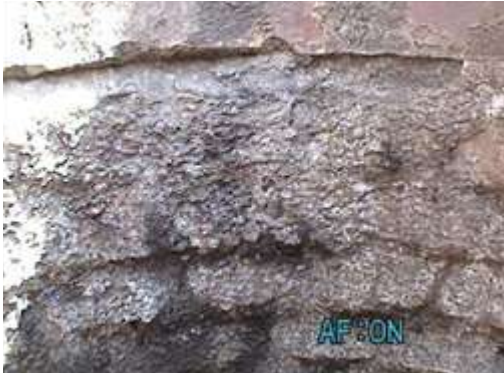
Defect 3

infiltration coming from chimney frame connect and loose bricks missing mortar

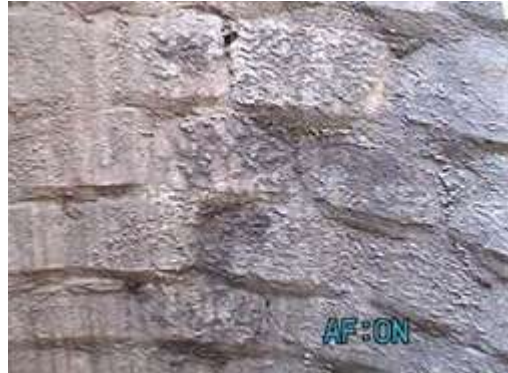
Defect 2

infiltration corbel

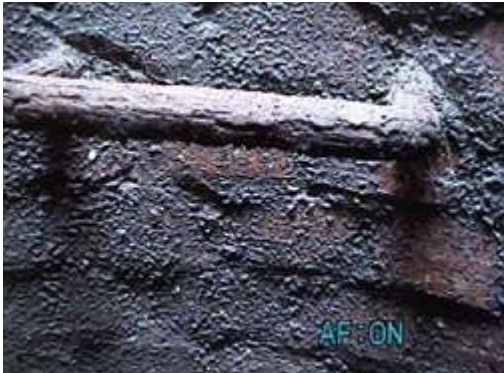
Defect 1

corroded rungs
